Mingenew Hall Report 2024

6 February 2024

Part 2. Existing Building Condition Summary

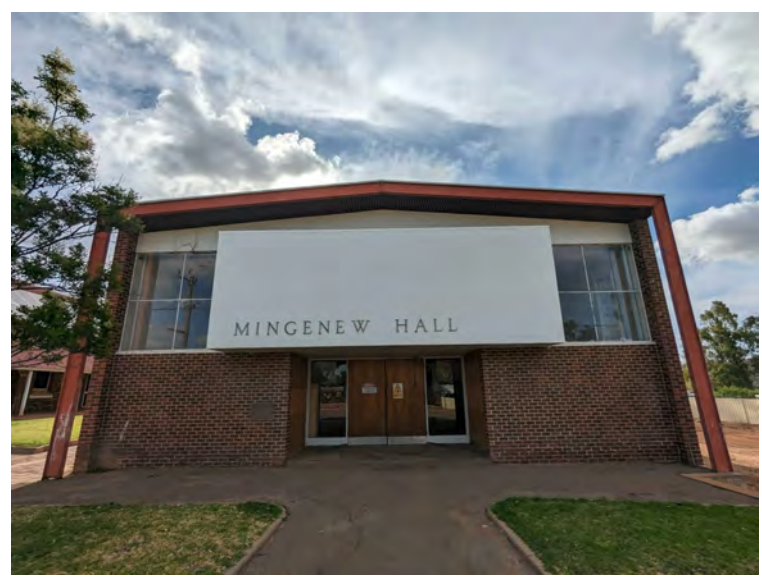
Bio Box

This old projector and light control room is currently full of costumes. These can be kept here or the room used as a chill space during events
Paint all around the outside box to emphasise its volume
Paint internal brickwork
Replace ceilings and insulate
Open up projection slots
