Mingenew Hall Report 2024

6 February 2024

Part 2. Existing Building Condition Summary

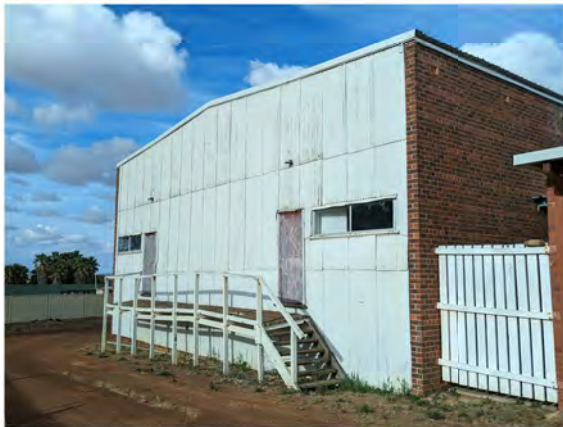
Western Wall

The asbestos corrugated sheeting to be removed. Reclad with corrugated colorbond steel sheeting on 70x35 softwood battens. Insulate with batts, and foil + cavities. Allow to batten or nog out inside to manage frame variation and modern sheet sizes. Consider 13mm plasterboard or 9mm FC for higher strength.
